**Heritage Impact Assessment**

**The Former Legislative Council Building (Old Supreme Court Building)**

Relocation of The Court of Final Appeal and the Development Office of The Judiciary to The Legislative Council Building

11 May 2012

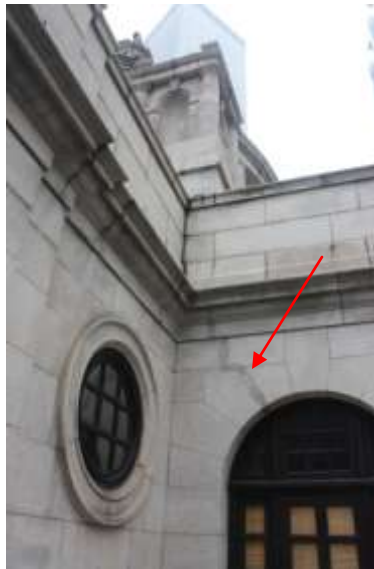
In late 1970s, dewatering process in underground during construction of the Charter Station (now named Central Station) of Mass Transit Railway led to uneven ground settlement. Severe structural cracks found throughout the building and construction noise

Fig. 23 Cracks developed on various locations on the building which led to the temporary closure of the entire building in 1978 for restoration. The photo shows one of the cracks located on the granite surface in 2/F under the central dome being repaired in 1980s. (Pointed)

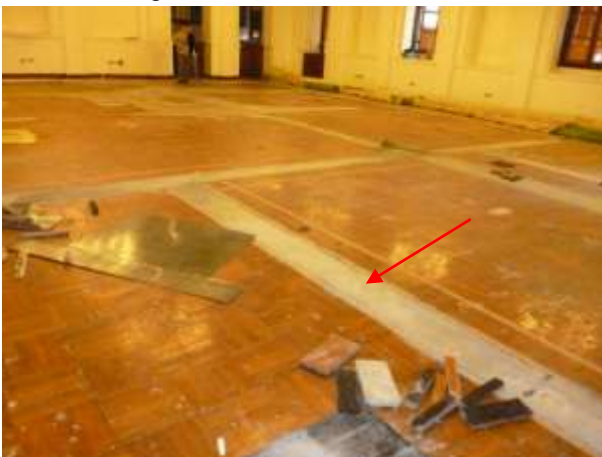
In 1985 conversion work, the south room was converted into Conference Room A and the north room was converted into Dining Hall. The Existing condition of the Conference Room A is covered with modern wall panels and is stood on a raised platform, it is necessary to dismantle the current fitting in order to examine the condition of the above captioned building features. The removal of carpets in the Dining Hall showed that the flooring is covered with square-patterned timber strips. Part of the original floor is destroyed by modern trunk works.

The square-patterned timber strip flooring finish reviewed after the removal of carpets. Trunk damages are discovered. (pointed)

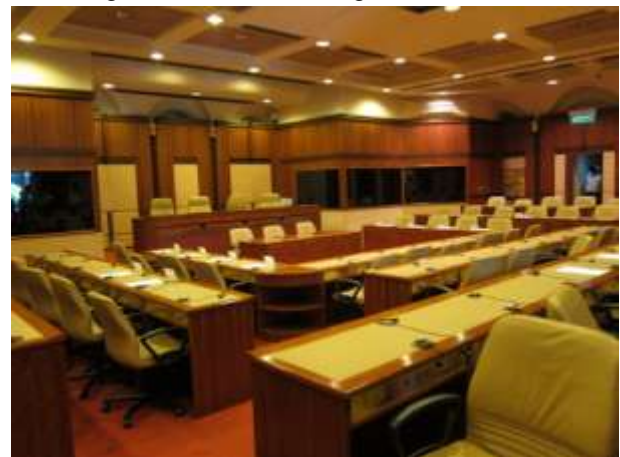
The renovated Conference Room A is extensively renovated which all walls are currently hidden by modern fittings

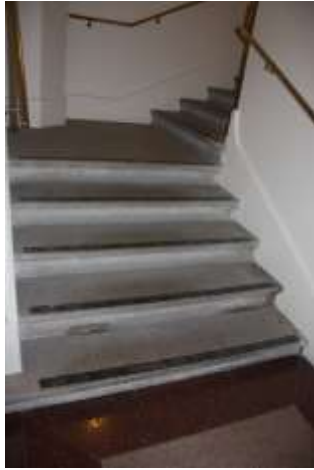
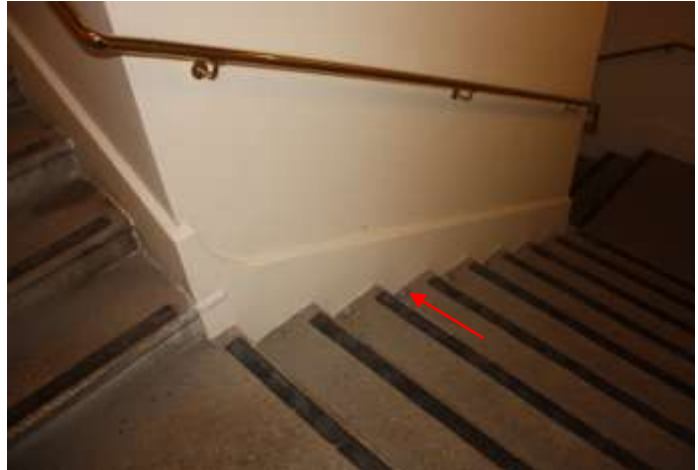
The original handrail has been replaced with modern handrail design and traces of original handrail footing can still be visible on the edges of the granite steps. Other

Fig.69 (left) and Fig. 70 (right) The preserved original granite staircase including the exposed granite steps and the footings with traces of original footing of the handrails (pointed).

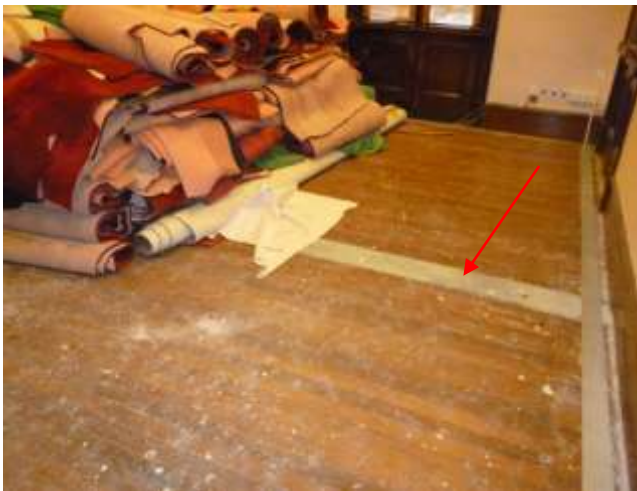
The general condition of the timber strip floors is poor in general. Those discovered are found rotted and destroyed by modern service trunks. There are no any rooms preserve undamaged original timber strip flooring. The best floor condition being discovered is inside the Ante Chamber. It is believed to be re-laid in 1985 and was covered with a thick layer of crystal wax.

Fig. 73 (left) Pictures showing a room with original timber strip flooring. The floor was damaged by trunk work (pointed)

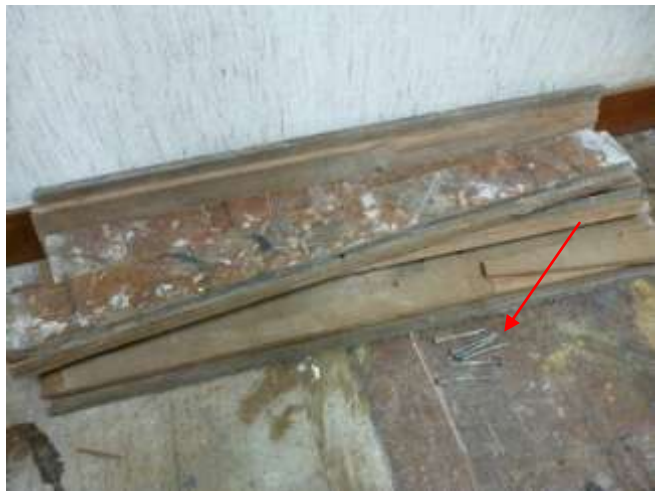
Fig. 74 (right) Some of the salvaged timber strip with moderate condition and the original fixing iron nails (pointed)

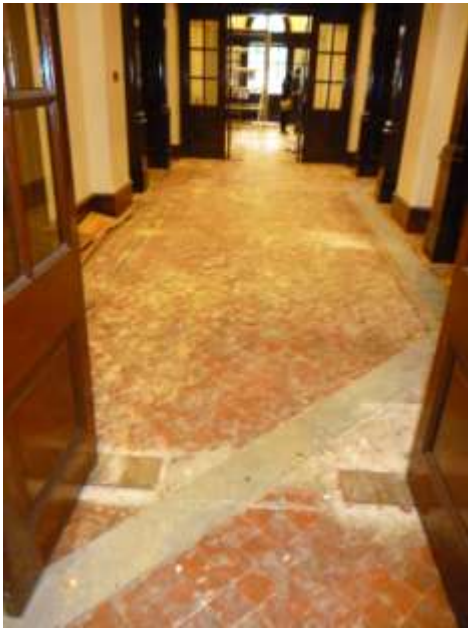
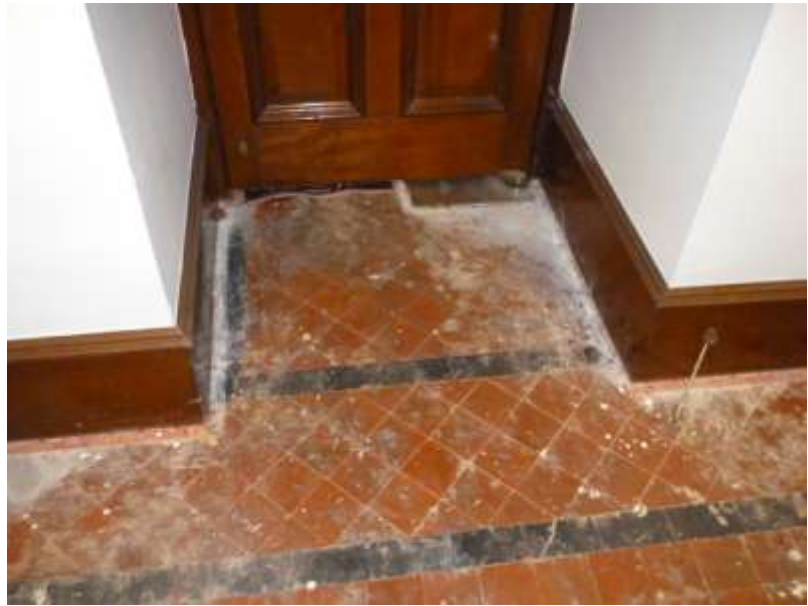
Most of the ceramic tiles are discovered in public area such as corridors, verandahs and inside some E&M rooms in 1/F. The existing condition of ceramic tile flooring is in poor condition. Most of them are heavily damaged by service trunks and covered with cement. In some areas such as the two vertical running corridor between Statue Square and Jackson Road, the entire floor has been replaced with modern stone works which no traces of original tile finish are found. One finding is the discovery of the original horizontal connecting corridor in between the two vertical running corridors in G/F which was shown in 1953 drawings but enclosed in 1985.

Fig. 78 (left) and Fig. 79 (right) Pictures showing the discovered original floor tiles (Fig. 78) with its detailed patterns (Fig. 79) found in the corridor areas located in 1/F and G/F respectively.

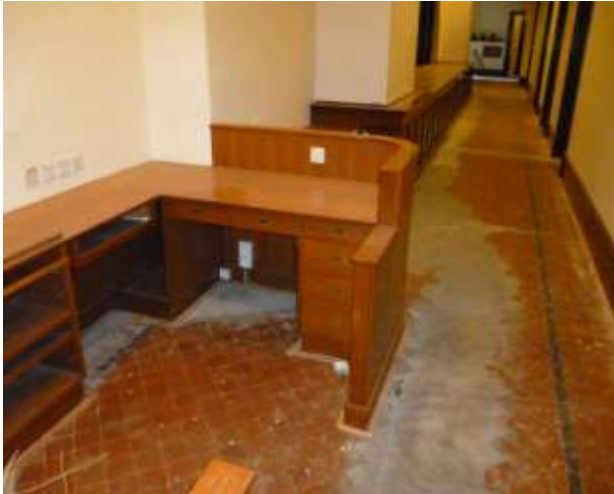
Fig. 80 (left) The exposed 2/F corridor. The existing tile surface is heavily damaged by later alteration works.

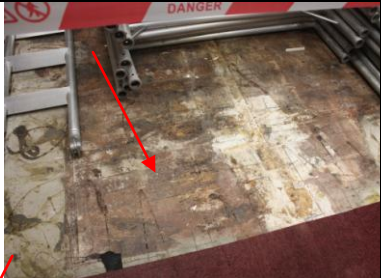
Moderate	<ul style="list-style-type: none"> <li>• Carpets were removed, and some existing cement floor surface was chipped off at strategic locations, to review the conditions of the original floor finishes.</li> <li>• Timber flooring was found in existing offices and conference rooms, while tiles were found in existing corridors.</li> <li>• The timber flooring that are in good condition will be preserved, those that are rotten and beyond repair will be removed.</li> <li>• The tiles that are in good condition will be preserved and cleaned with non-destructive and neutral cleanser.</li> <li>• If in-situ preservation is not possible, the flooring will be salvaged for replacement in other areas and exposed for public appreciation where possible. Those that are not exposed will be covered without damaging.</li> <li>• The extent of preservation and method statement will be submitted to AMO for agreement in due course.</li> <li>• The traditional nailing technique will be adopted as far as practical during replacement of timber flooring.</li> <li>• Anti-termite treatment will be applied to the preserved timber flooring.</li> </ul>	Acceptable Impact with mitigation measures
