**Heritage Impact Assessment**

**The Former Legislative Council Building (Old Supreme Court Building)**

Relocation of The Court of Final Appeal and the Development Office of The Judiciary to The Legislative Council Building

11 May 2012

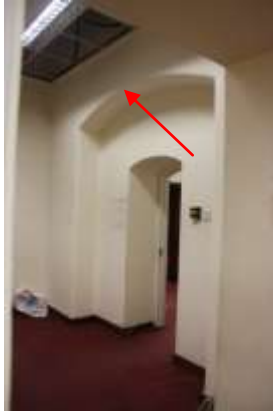
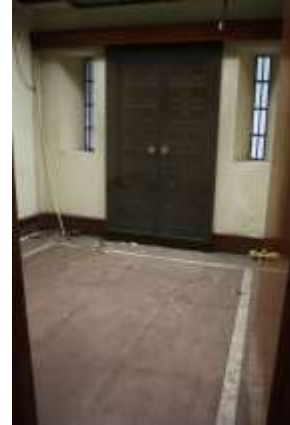
Fig. 46 (left) & 47 (right) The Former Prisoners' Receiving Area

The original segmental arched opening of one of the cells (pointed)

The prisoners' receiving entrance area with terrazzo floor finish

The door openings of the two cells have preserved its original segmental arched openings. However, existing openings are diminished with new brickworks and the two cells are interconnected with new rectangular opening.

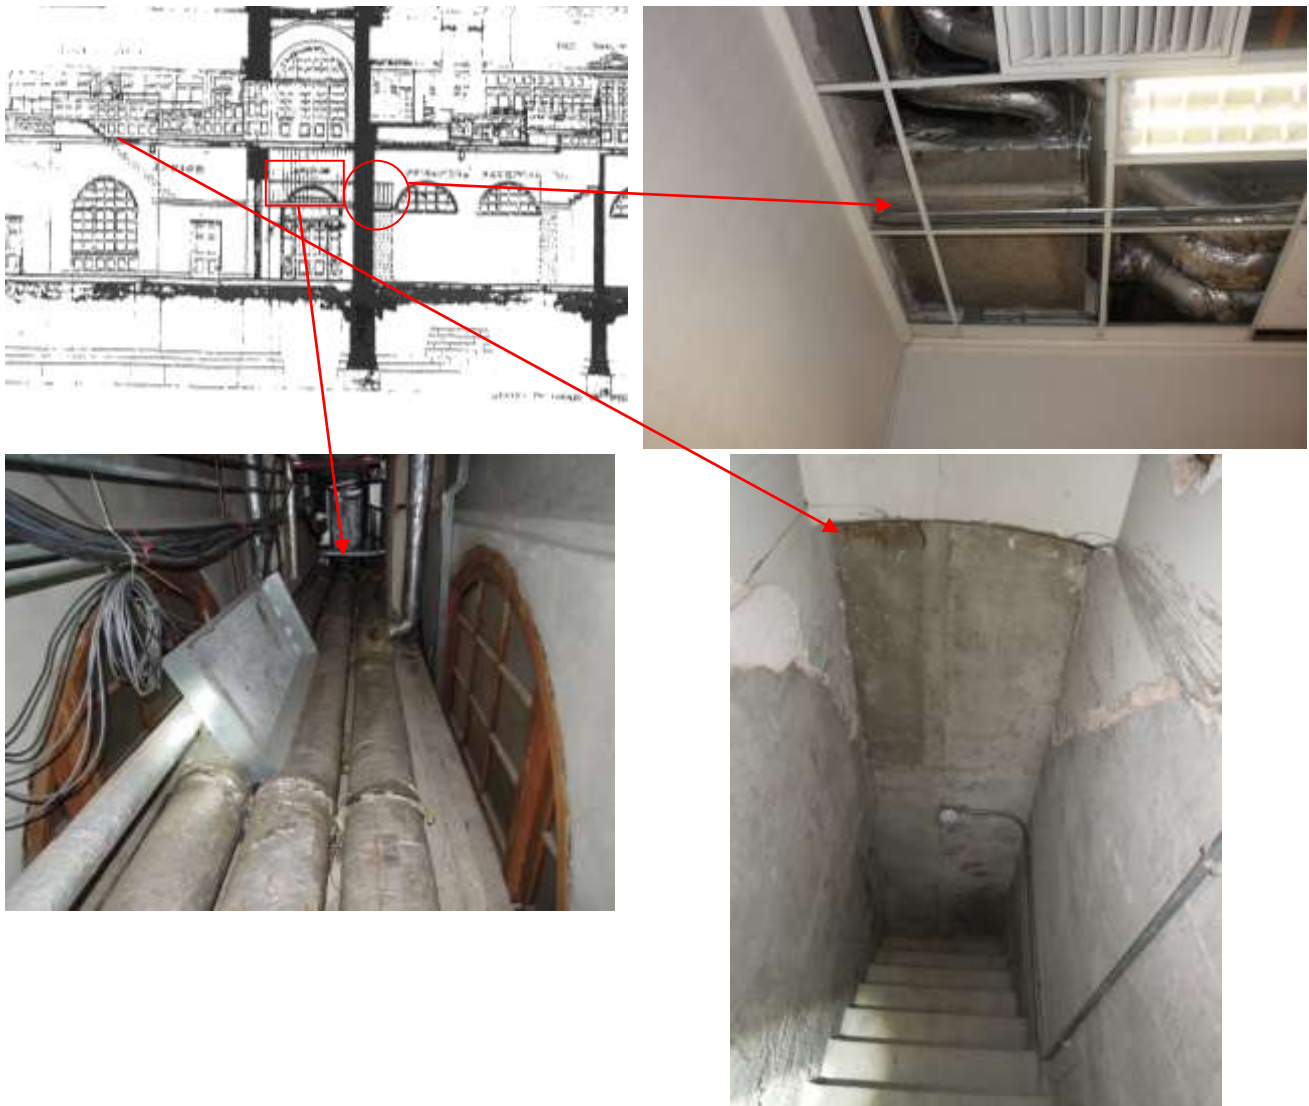
The two bridges were constructed with granite. Existing condition reviewed that most of these structures were disappeared except the part of bridge on mezzanine level to the second court. The landing of the bridge is only visible after dismantling the false ceiling of Room 010 of LegCo. It is found that this bridge is running on top of the existing middle timber doorway partition locating on the north corridor. Many building services is now occupying the bridge area and there is no metal railing observed flanking the staircase. Careful examination of the bridge is essential after removal of the occupying services

Fig. 49 (upper right) shows the existing staircase landing found after removal of false ceiling

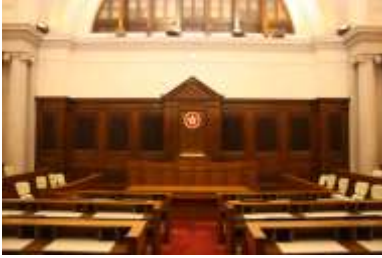
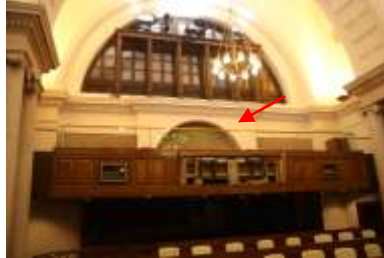
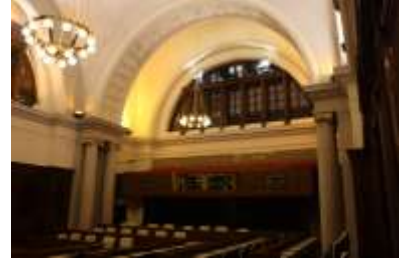
Fig. 54 – 56 (left to right) Details of the Great Chamber

Removal of carpets inside shows that original timber strips are still preserved however it was damaged by modern service trunks.

Overview of chamber showing the current chamber seat and existing timber wall panel.

The north public gallery later added. The original arched moulding is still visible

The barrel vault and granite double column bases are still intact

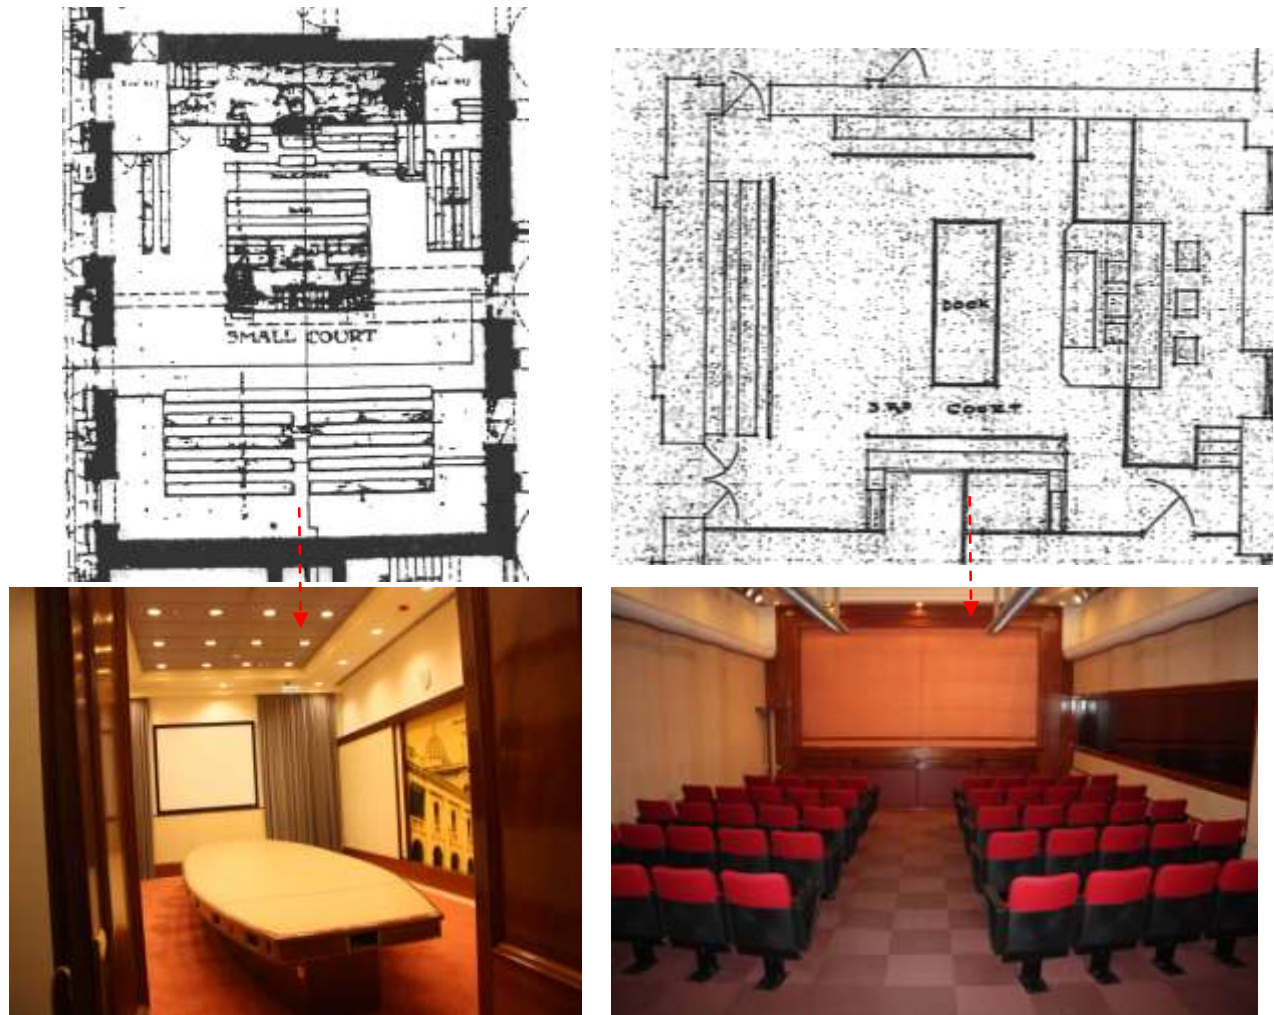
The 1985 conversion work had changed this area into the LegCo Press Conference Room. All the original fitting was removed to accommodate new fitting. Recent removal of carpets discovered that half of the original timber floor strips are still preserved however they are heavily damaged by lateral service trunks.

Fig. 57 – 60 (Left to right, top to bottom) The original design drawing of the small court (1899) and the existing layout (2012, Former LegCo Conference Room B). The 3<sup>rd</sup> Court (1953) and the existing layout (2012, Former Press Conference Room)

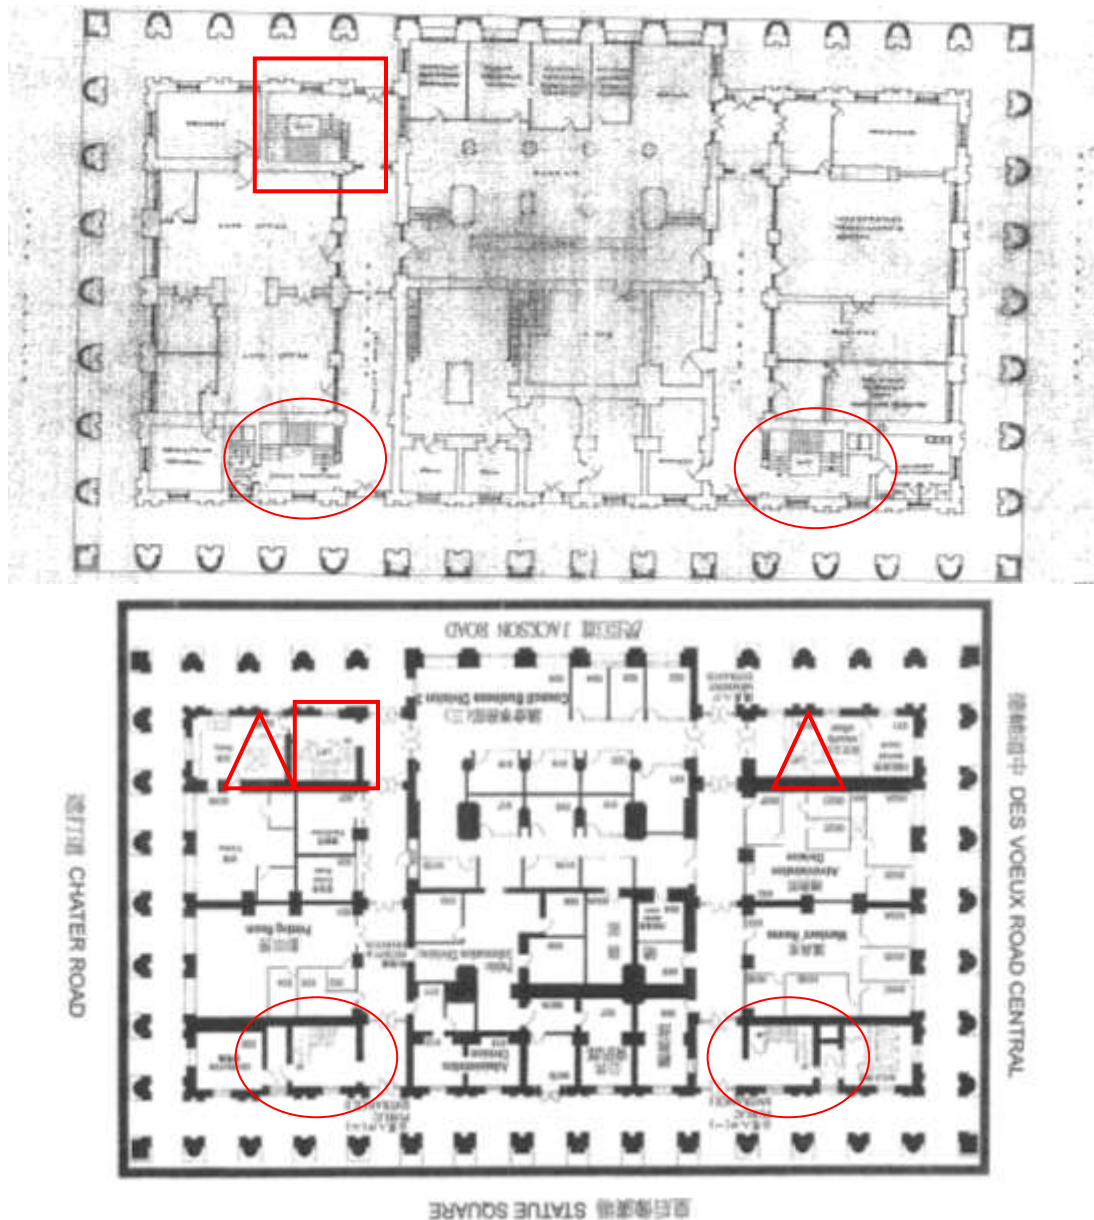
The 1985 conversion work only preserved the original staircase located at the northeast corner while the others were rebuilt by concrete. All the two lifts were reconstructed with an additional lift added to the southeast corner. A dump waiter was added in the pantry locating at the northeast corner to serve the dining hall in 2/F.

Fig. 68 (above) and Fig. 69 (below) shows the G/F plan of the Supreme Court (1953) & LegCo (2011) showing the location of all vertical circulations including the preserved original granite staircase (squared) with a new lift inserted in its central void, the reconstructed staircases (circled) and the newly built lift and dump waiter (triangled).

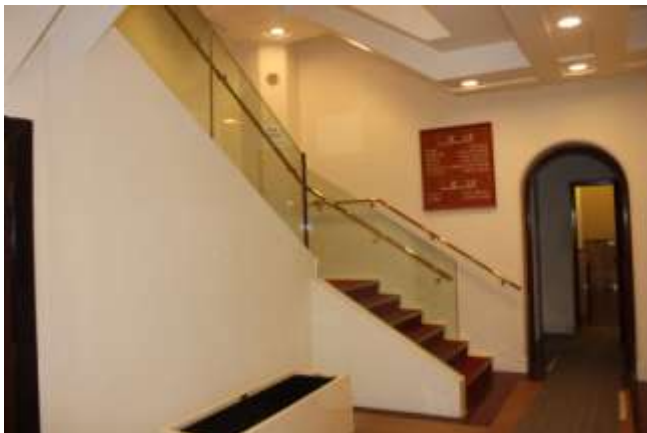
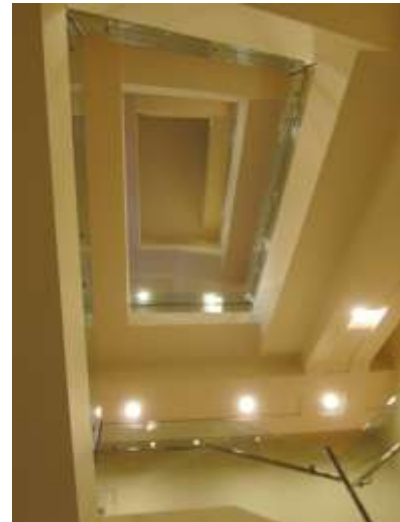
Fig. 71 (left) and Fig. 72 (right) One of the typical layout of the two reconstructed staircases done in 1985 conversion work. The staircase is constructed with concrete with glass panels balustrades spiraling around the central well to 2/F.

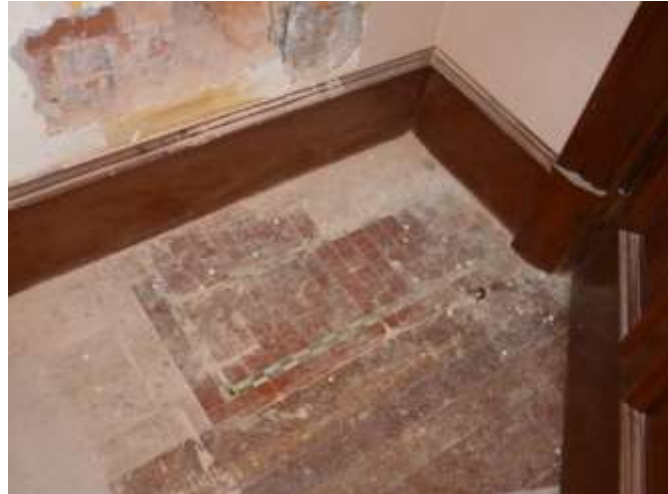
Fig. 81 (right) The ceramic tile surround at the original location of the fireplace are discovered in Room 109 & 112 in 1/F of the building

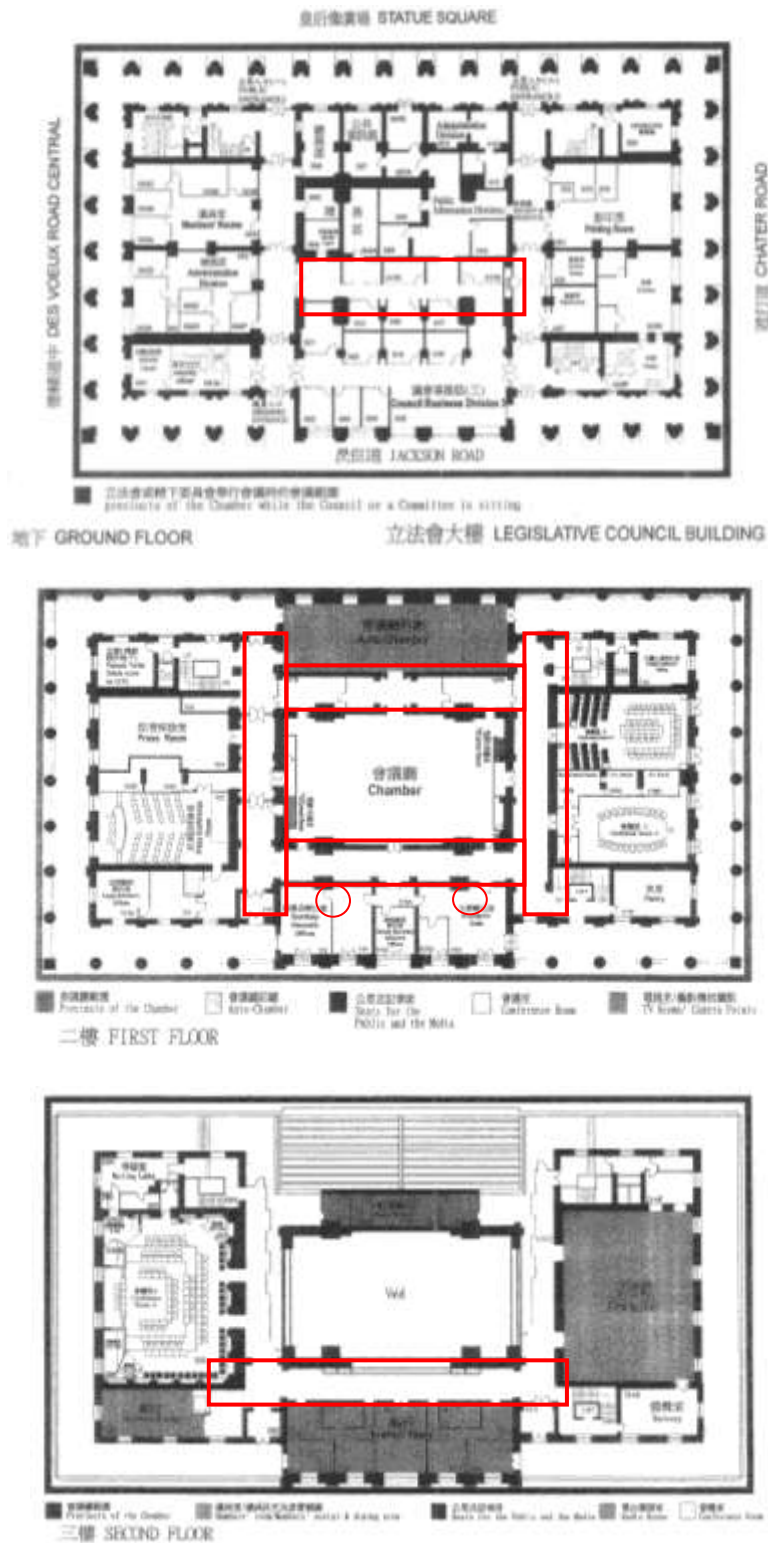
Most of the ceramic tiles are discovered in public area such as corridors, verandahs and inside some E&M rooms in 1/F. The existing condition of ceramic tile flooring is in poor condition. Most of them are heavily damaged by service trunks and covered with cement. In some areas such as the two vertical running corridor between Statue Square and Jackson Road, the entire floor has been replaced with modern stone works which no traces of original tile finish are found. One finding is the discovery of the original horizontal connecting corridor in between the two vertical running corridors in G/F which was shown in 1953 drawings but enclosed in 1985.

Fig. 82-84 (top to bottom) Floor plans showing the distribution of original ceramic tile finishes (squared in red) and ceramic tiles surround (circled) indicating the location of the old fireplaces discovered in each floor after the carpet removal in Mar 2012.

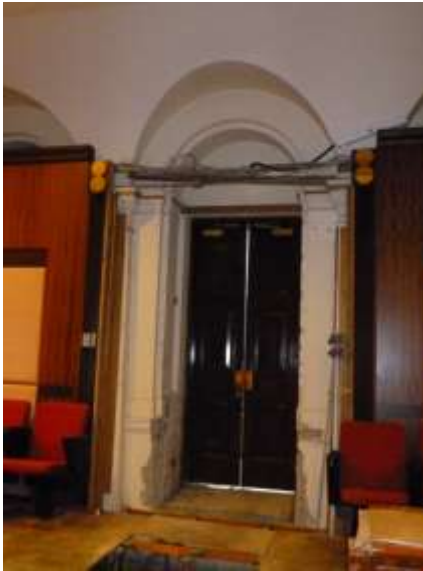
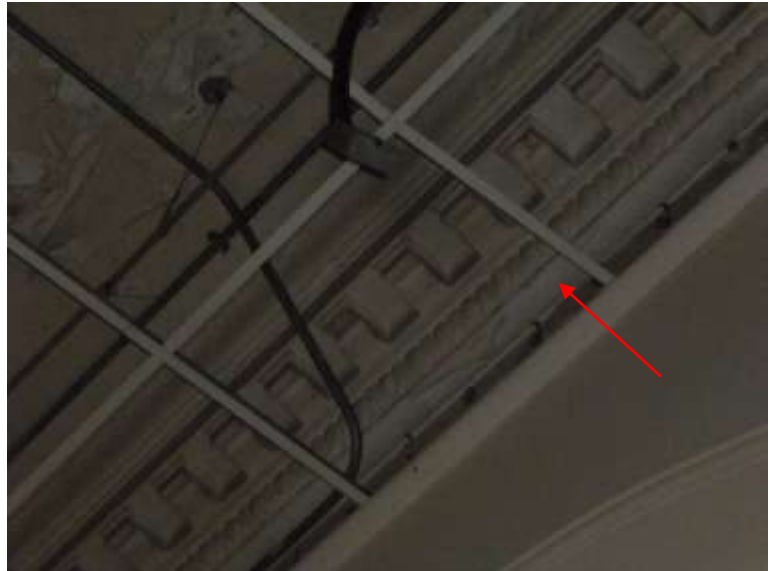
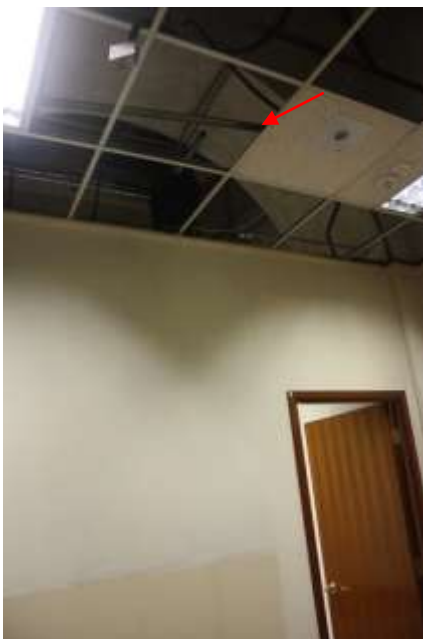
Fig. 85-87 (left to right, top to bottom)

Some of the original building features discovered after partial removal of modern fitting including the wall moulding (2/F Conference Room A, Fig. 85), dentil moulding on ceiling (discovered in G/F & 2/F ceiling, Fig. 86) and original arched doorway (mostly in G/F, Fig. 87)

It is recommended that further open up of modern false ceiling and modern wall fittings are essential to examine the existing condition of the wall finishes and moulding.

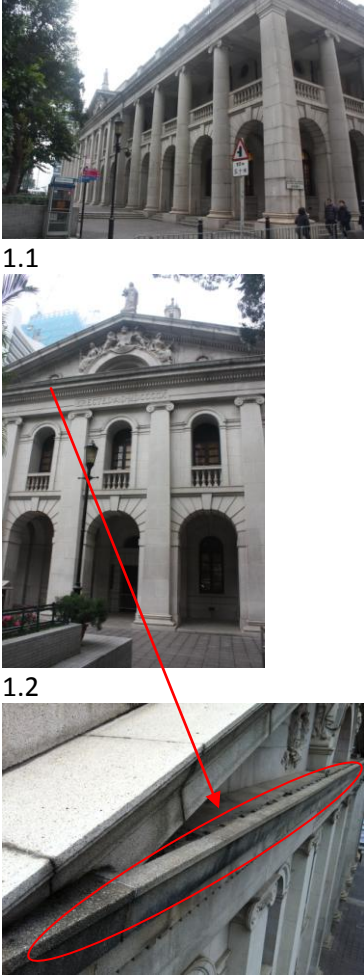
Item No	Identified Elements / Materials	Photo and Ref.	Level of Significance	Recommended Treatment/ Justification/ Mitigation Measures	Impact Level
1.1	<p>Main Elevation (West elevation facing Statue Square)</p> <hr/> <p>Proposed Use / Alteration</p> <ul style="list-style-type: none"> <li>Propose to repair/remove the deteriorating concrete fins after careful study</li> </ul>

<p>1.1</p> <p>1.2</p> <p>1.3</p>	Exceptional	<ul style="list-style-type: none"> <li>Preserve in-situ the entire external wall and retain the openness of the 1/F verandah and G/F colonnade.</li> <li>No painting will be applied on the granite surface.</li> <li>General cleaning to the granite surface will be carried out by accredited methods causing no damage to the granite.</li> <li>Repairing works will only be carried out if crack is discovered. Mortar mix with granite chips matching adjacent granite surface will be used for repairing.</li> <li>Later-added precast concrete fins in dilapidated condition are identified at the base of the pediment. Study will be carried out to confirm whether those fins are post-war construction before taking any action to the fins. Further proposal will be submitted to the AMO for approval. (1.3)</li> </ul>	Beneficial

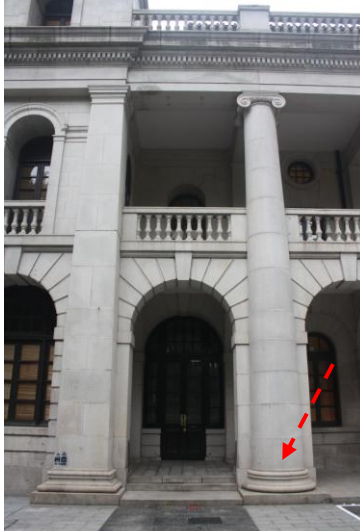
Exceptional	(cont'd) <ul style="list-style-type: none"> <li>The existing ramps were constructed in the 1980s by modifying the level of the original granite floor. The gradient of the ramps could not meet current statutory requirement on barrier free access. Exemption for not complying current standard will be applied to relevant authorities, as persons with disability could be assisted by management staff. (1.7)</li> <li>If exemption could not be granted, the gradient of the ramp at the right entrance on this façade will be modified by adding a ramp of demountable materials on top of the existing one, so that no irreversible damage will be caused to the granite elements. (1.8)</li> </ul>	Acceptable with mitigation measures

<ul style="list-style-type: none"> <li>Propose to modify existing ramp next to the rear right entrance from Jackson Road to fulfill the current barrier free access standard, if exemption could not be granted.</li> </ul>				
	Site Location				
<p style="text-align: center;"><b>Statue Square</b></p>
